Failure Analysis of Three Si_3N_4 Balls

1 December 2001

6. AUTHOR(S) M. J. O'Brien and N. Presser		5d. PROJECT NUMBER		
		5e. TASK NUMBER		
		5f. WORK UNIT NUMBER		
7. PERFORMING ORGANIZATION NAME(S) AND ADDRESS(ES) The Aerospace Corporation Laboratory Operations El Segundo, CA 90245-4691		8. PERFORMING ORGANIZATION REPORT NUMBER TR-2001(8565)-1

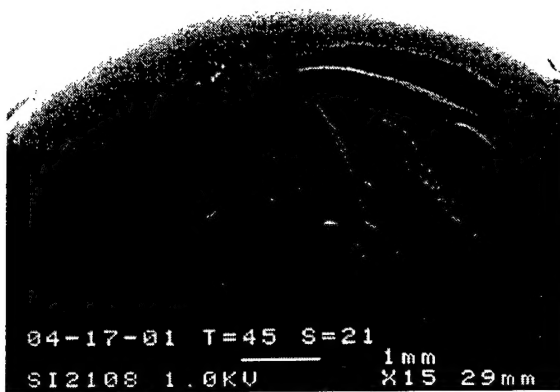
Fig 1

Figure 1 is a low-magnification view of the entire spall from a perspective perpendicular to the spall. The circular Wallner lines seem to radiate on the left and right from an initiation site labeled "A," with the concave sides of the Wallner lines pointing back towards this initiation site. The site labeled "A" is a broad, flat "plateau."

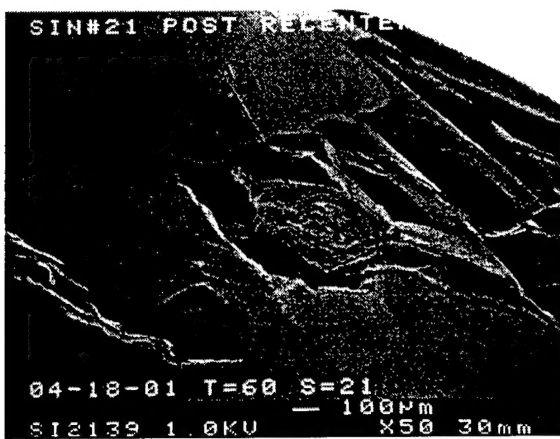
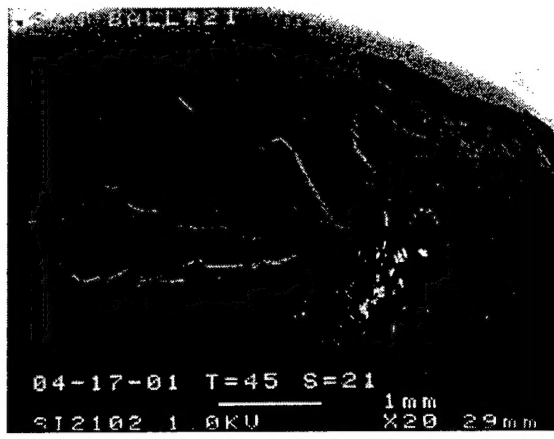
Figure 2 is another low-magnification view centered on site "A" showing the neighboring Wallner lines more distinctly. Figure 3 is a slightly higher magnification view at 50x centered to the right-hand side of the site "A" and Figure 4 is a companion view at 20x centered to the left-hand side of the site "A." Figures 3 and 4 are taken at oblique angles to highlight the concave Wallner lines, which again point back towards the site "A," which is therefore identified as the initiation site.

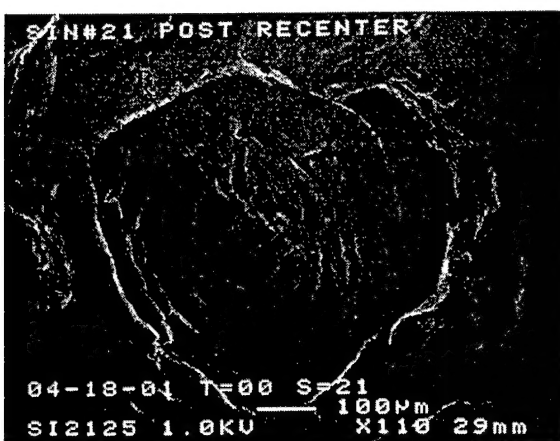
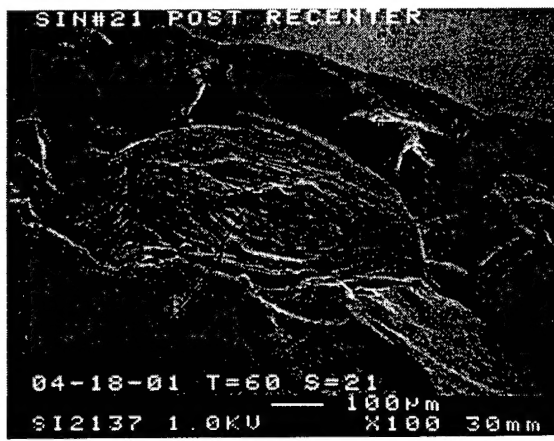
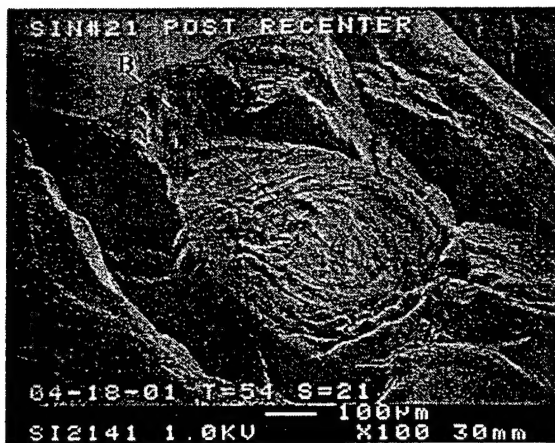
Figures 5, 6, and 7 are a series (at magnifications of 110x, 100x, and 100x) centered on the site "A." Figure 5 is from an orthogonal perspective, and Figures 6 and 7 from oblique perspectives. The circular Wallner lines seen in site "A" form a "bull's eye" pattern around a central point, labeled "B," which is within the region labeled "A" and approximately in its center. The pattern of Wallner lines implies that site "B" is the upstream location where failure initiated.

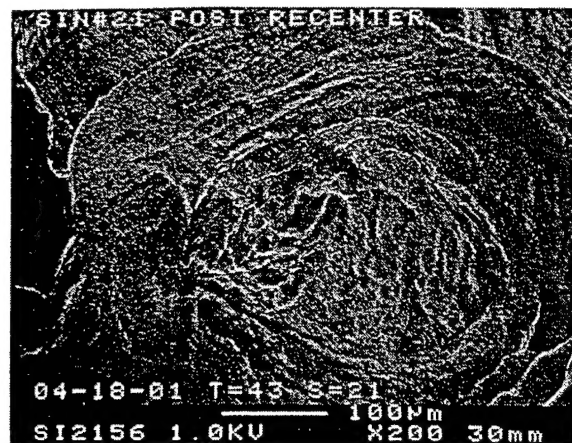
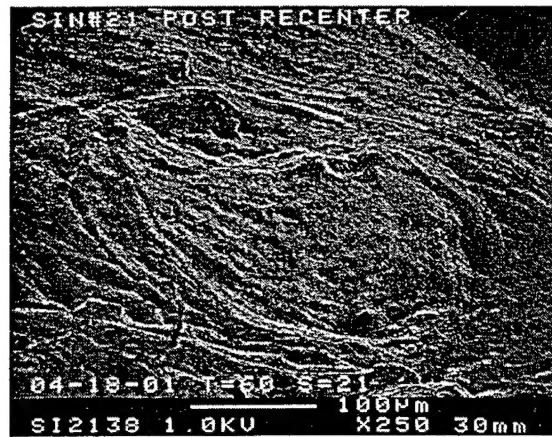
Figures 8 and 9 are views at 200x and 250x centered at site "B." Detailed inspection of site "B" at still higher magnifications did not seem to reveal a clear cause for the initiation of the fracture on site "B."

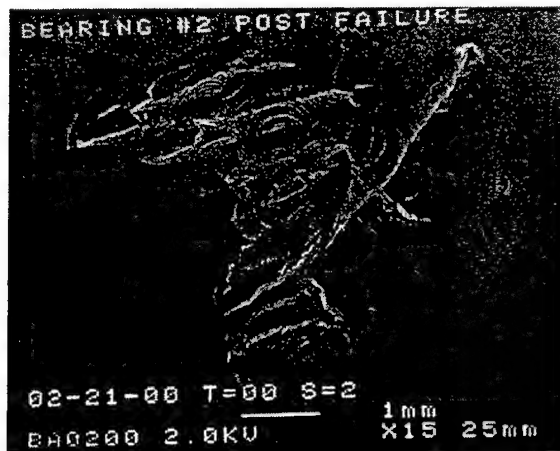
Fig 10.

Figure 10 is a low-magnification view of the entire spall from a perspective orthogonal to the spall. The circular Wallner lines are evident in the upper and middle parts of the spall, and the concave lines seem to radiate back to a point in the lower part of the spall. To orient the discussion of subsequent fractographs that show finer detail, four features are labeled in Figure 10. Feature "A" is a region of Wallner lines in the middle of the spall. Feature "B" is a region of Wallner lines in the lower part of the spall. Feature "C" is a void in a triangular pocket defined by the intersection of three cracks. The long diagonal line labeled "D" is a deep "trench-like" fracture that is not obvious from this perspective.

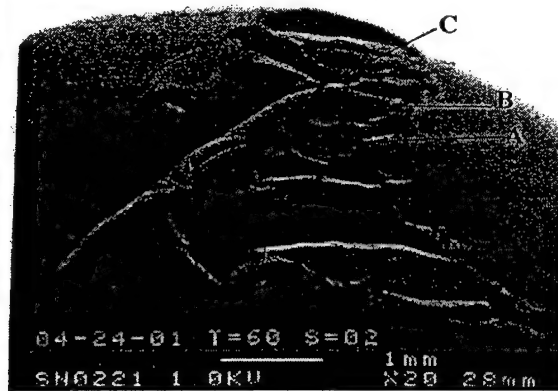
Fig 11

Figure 11 is a low-magnification oblique view showing better the Wallner lines in the upper region of the spall. Features "A" and "B," which are the regions of Wallner lines, are labeled and reinforce the observation that the upstream location of the fracture initiation is in the lower part of the spall with the middle and upper parts of the spall downstream from the initiation site. The location of the void

is labeled "C," although the triangular pocket is not obvious in this view. The long and deep fracture, labeled "D," is more obvious in this view. An interesting feature, labeled "E," is a patch of virgin surface that did not spall away.

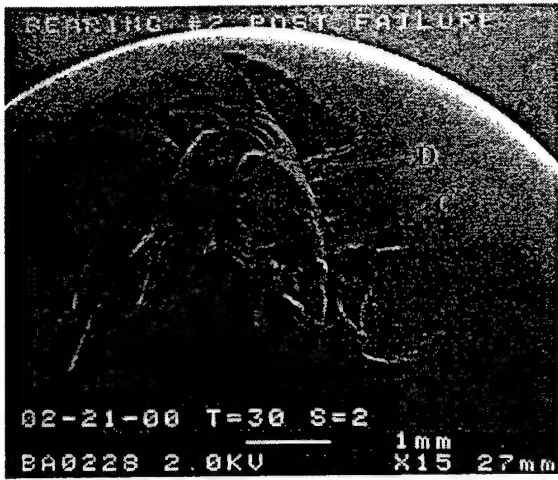
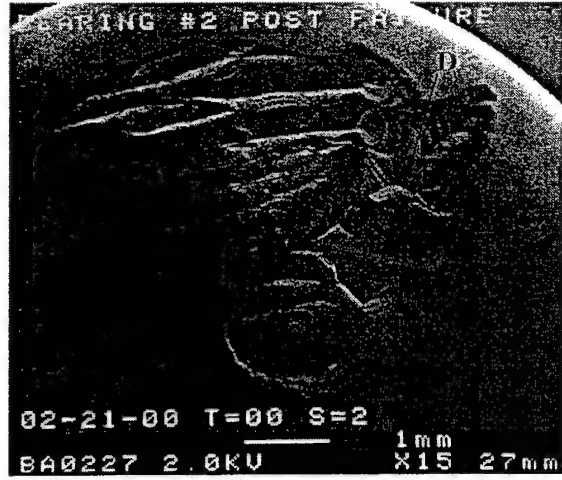
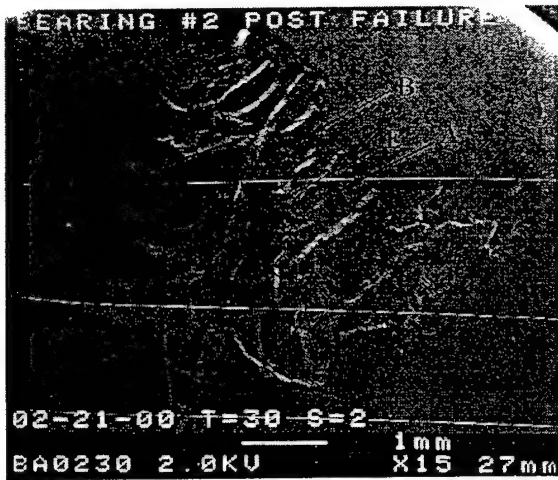
Figures 12, 13, and 14 are low-magnification views taken by successively rotating the line of sight. The concavity of the regions of Wallner lines, labeled "A" and "B," again reinforce that fracture initiation occurred in the lower part of the spall. The location of the void, labeled "C," is labeled in the lower part of the spall. The deep fracture, labeled "D," is seen to intersect the void. Actually, these three views cumulatively show that three separate fractures intersect at the void. To provide a landmark, the location of the unspalled virgin surface is labeled "E."

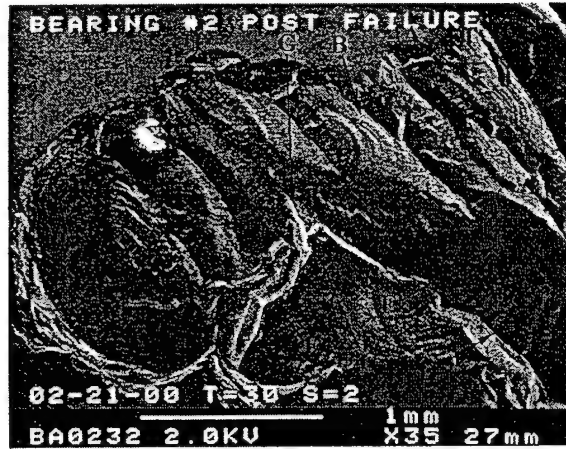
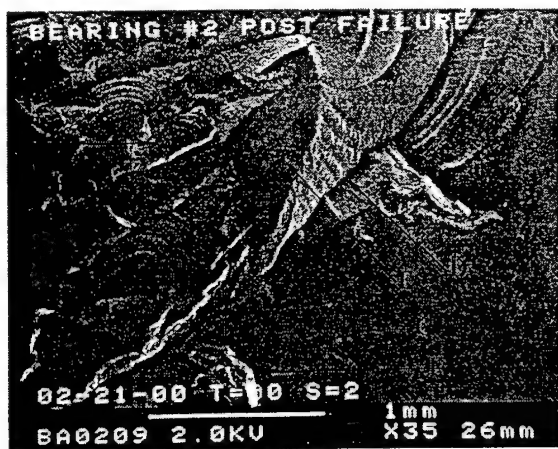
Figures 15 and 16 are orthogonal views of the lower part of the spall at higher magnifications. The Wallner lines, labeled "A" and "B," show that fracture initiated between region "B" and the lowermost part of the spall. That is, region "A" is downstream of region "B," which, in turn, is downstream of the site of fracture initiation. Void "C" is located in this area upstream of the region "B" and is considered a possible candidate responsible for initiation of the spall. The deep crack, "D," radiates from the void, as do two other cracks, labeled "F" and "G".

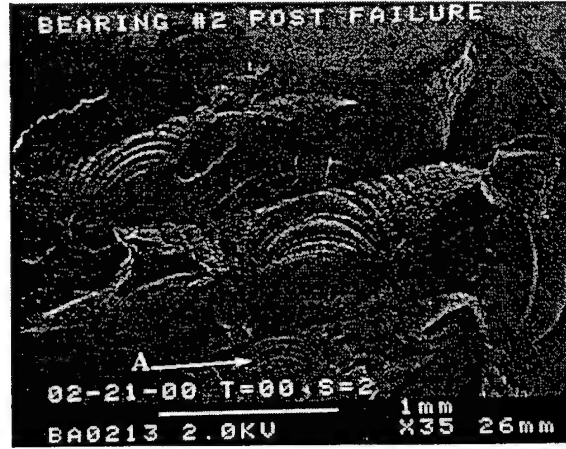
Fig 17

Figure 17 is an higher magnification orthogonal view of the middle and upper parts of the spall. The Wallner lines labeled "A" are visible, although the other region of Wallner lines, "B," is just beneath the lower edge of the frame and is not visible. Again, the concave sides of the Wallner lines point upstream to the site in the lower part of the spall where fracture initiated.

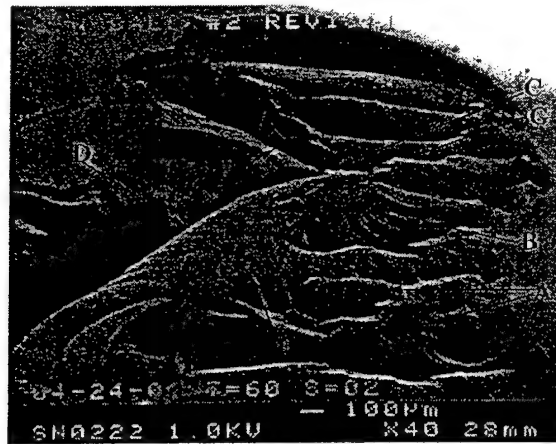
Fig 18

Figure 18 is an oblique view taken from a line of sight from the upper part of the spall. The Wallner lines, "A" and "B," are labeled. The void, "C," is not visible, but its location is labeled. The three cracks, "D", "F," and "G," are seen to be radiating from the location of the void. As a landmark, the unspalled spot of virgin surface is labeled "E".

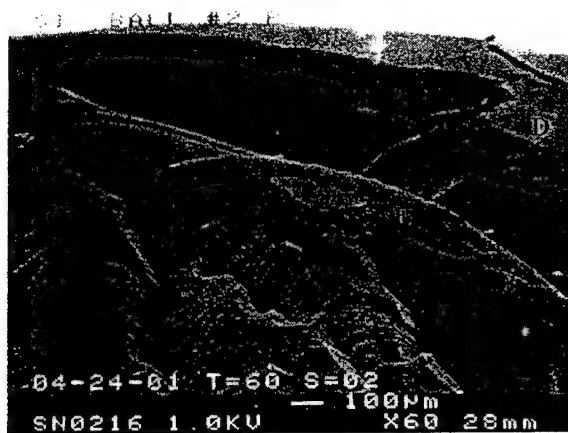
Fig 19

Figure 19 is an oblique view of the middle part of the spall whose line of sight is rotated from the line of sight used in Figure 18. The Wallner lines, "A" and "B," and the unspalled spot, "E," are labeled. The deep crack, "D," is seen running diagonally across the back of the fractograph.

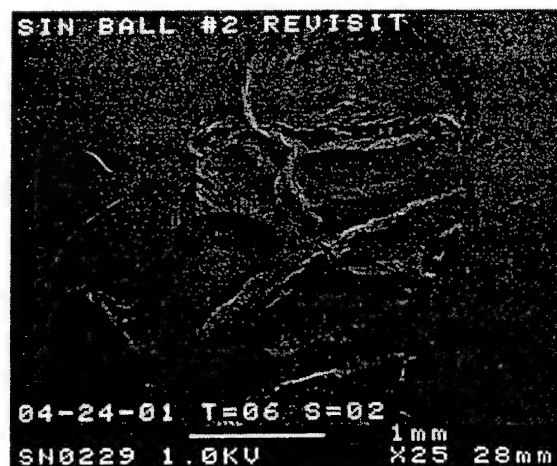
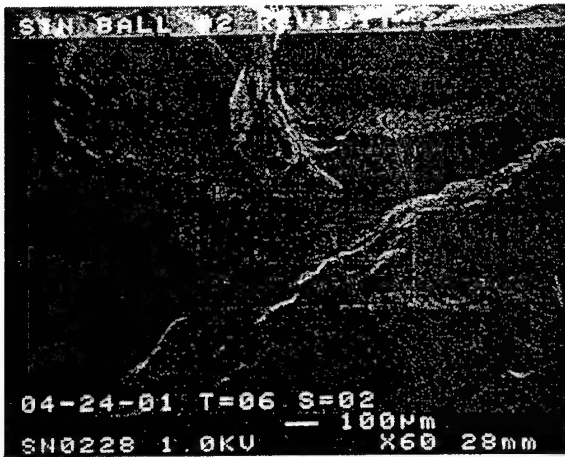
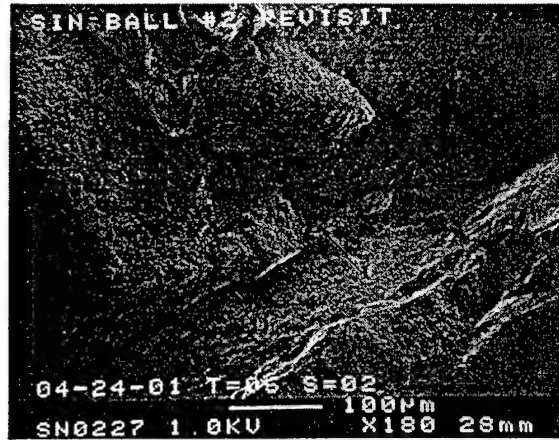
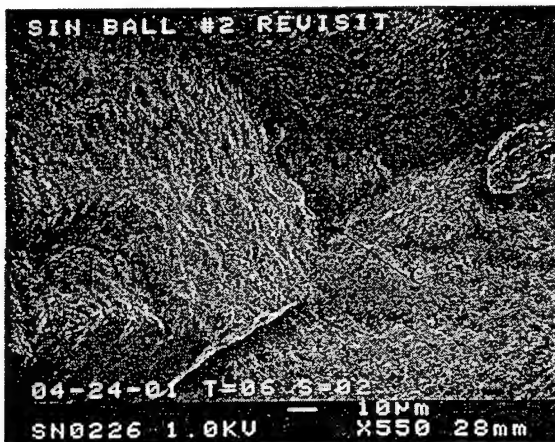
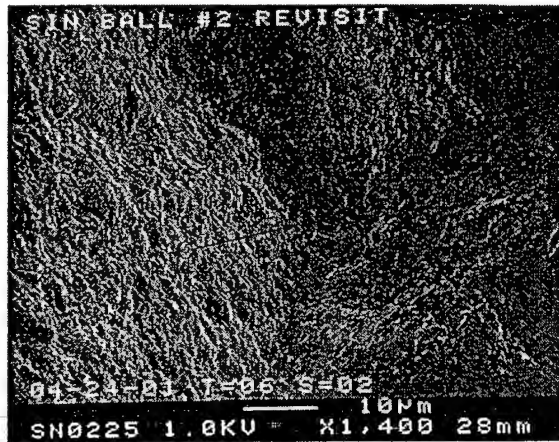
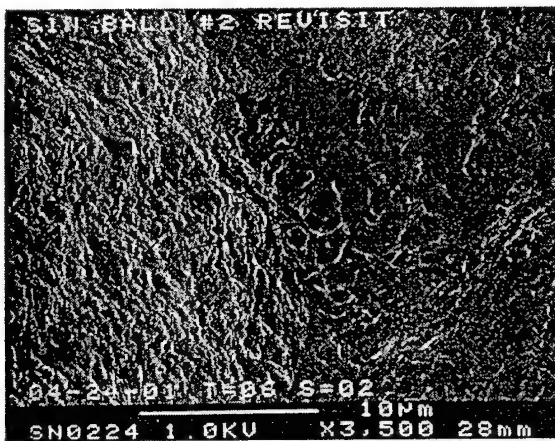
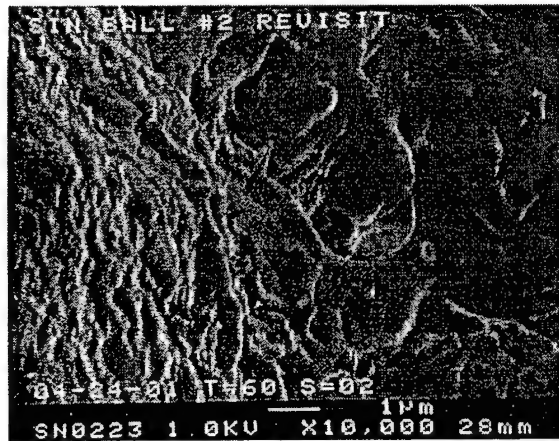
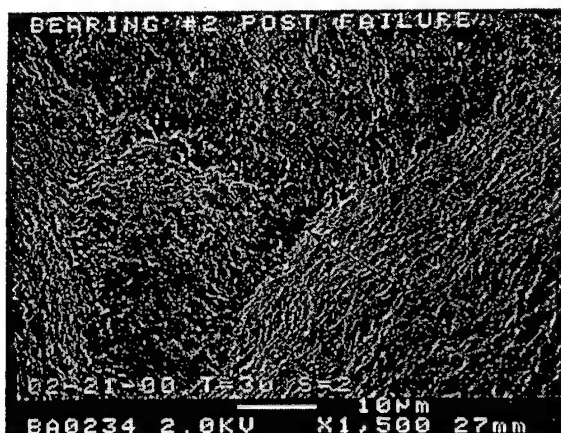
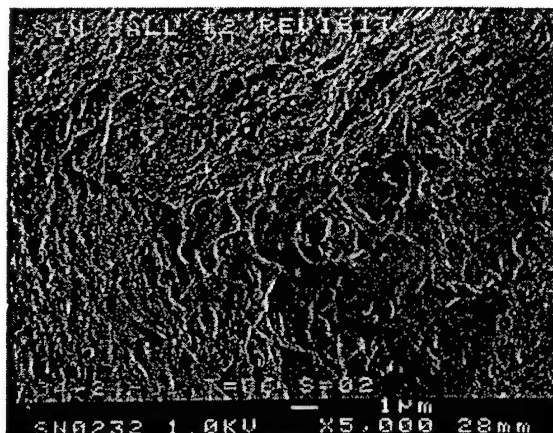
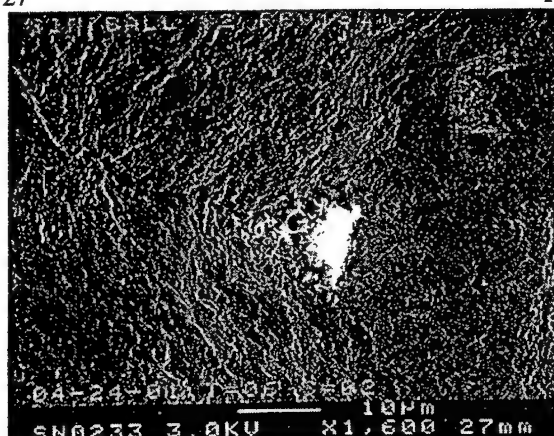
Figures 20, 21, 22, 23, 24, 25, and 26 are progressively higher magnification views (at 25x, 60x, 180x, 550x, 1400x, 3500x, and 10,000x, respectively) from an orthogonal perspective and centered on the void, "C," which is at the junction of the three cracks, "D," "F," and "G." Figure 27 is a view of the void at 1500x from a different perspective that "sights" down the bore of the void. Figure 28 is a view at an intermediate magnification of 5000x from still another perspective. Figure 29 is a micrograph at a slightly higher accelerating voltage, 3 kV, that shows that the region immediately around the void charges, although material further away does not.

The void, which is approximately 2 μm in diameter, sits in a triangular region whose appearance differs from the fracture surface around it, which is seen most clearly in Figures 25, 26, and 28. This change in appearance may imply that the triangular region is not the same chemistry as the material around it. For example, the region may be a pocket of segregated glassy material at the triple junction between adjacent grains of crystalline Si_3N_4 . The observation that the triangular region charges implies that the region has a higher electrical resistivity than the material around it. A higher electrical resistivity is consistent with a pocket of glassy material rich in the sintering aids used in this Si_3N_4 . The glassy sintering aids might be expected to be more insulative than the bulk Si_3N_4 ceramic.

Alternatively, the change in appearance might imply that the triangular region possessed a different history than the material around it during the fracture process. For example, if the void does happen to represent the initiation of the spall, then the region may be the site where a sub-critical pre-crack developed and slowly grew by fatigue over several million Hertzian loading cycles until it reached the critical size at which the rest of the spall fractured. During the course of the fatigue cycles, asperities may have been smoothed away as the opposing faces of the pre-crack opened and closed, giving the change in appearance compared to the larger fracture surface around it.

It is uncertain, however, whether the void represented the initiation site for the fracture, whether the void developed as damage late in the fracture, or whether the void was unrelated to the fracture. If the void was responsible for fracture initiation, it may be a small sintering pore where the ceramic did not fully densify.

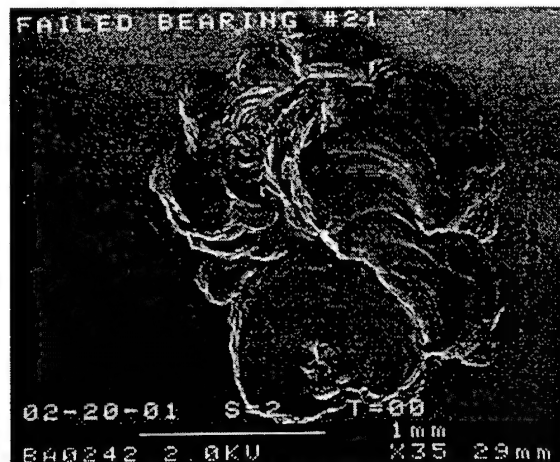
Figures 30, 31, and 32 are low-magnification views of the entire spall. The circular Wallner lines seem to radiate from a failure that originated in a broad, flat "plateau." The Wallner lines radiate down several "stepped" regions, with the concave sides of the Wallner lines pointing back towards the plateau from which the failure seems to have initiated. The concavity reinforces the notion that the plateau is "upstream" in the fracture, and the several stepped regions are "downstream." The feature "C" is labeled in Figure 32 but explained later in this discussion.

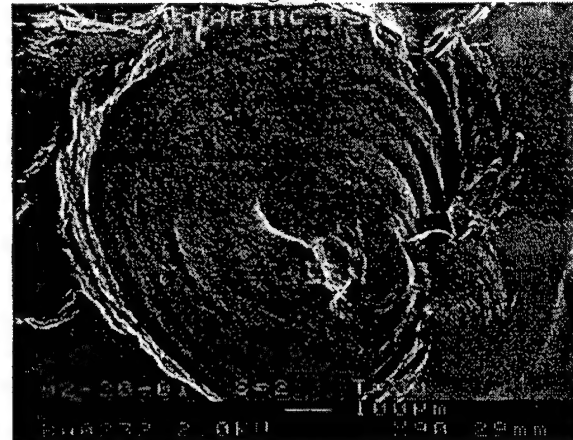
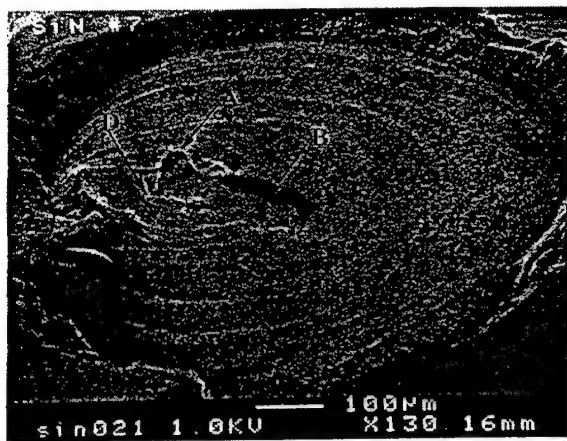
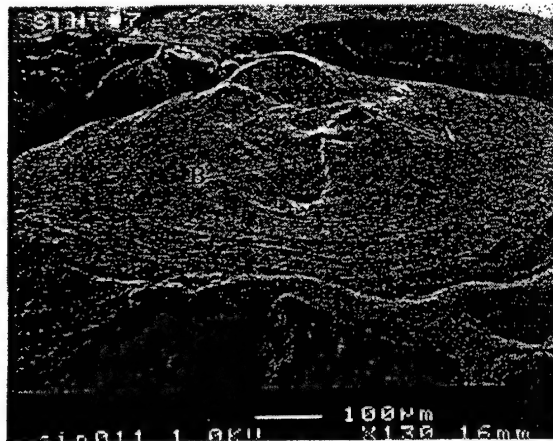
Figures 33, 34, and 35 are higher magnification views of the plateau from which fracture is believed to have initiated. The Wallner lines form a "bull's eye" pattern around a central point. The "thumb-

shaped" feature labeled "A" is a landmark used to orient subsequent discussion. Running off from point "A" is a crack-like feature labeled "B," which changes slightly in Figure 33. Another landmark is labeled "D."

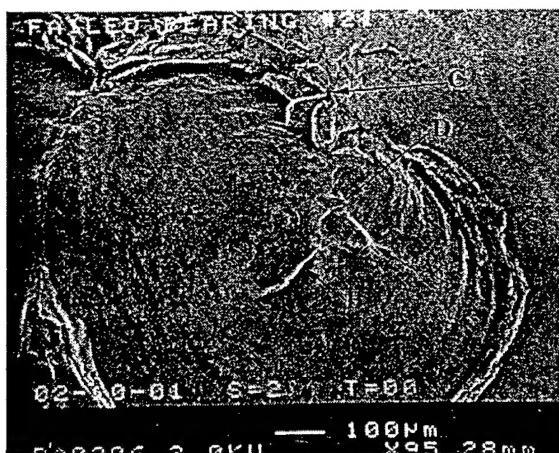
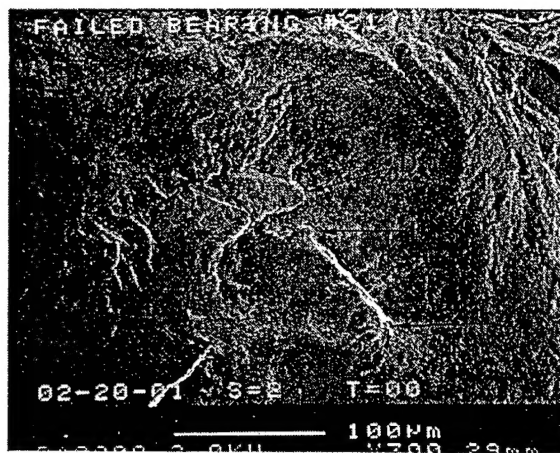
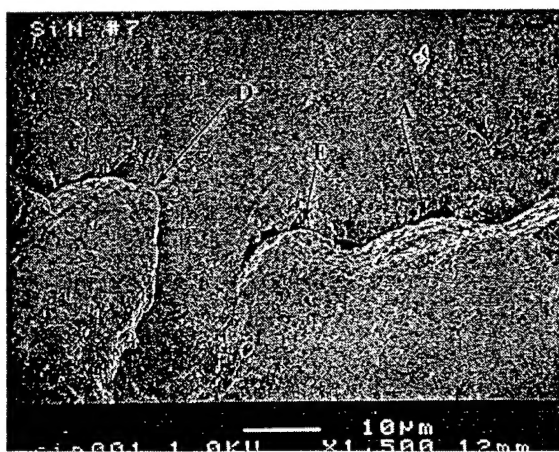
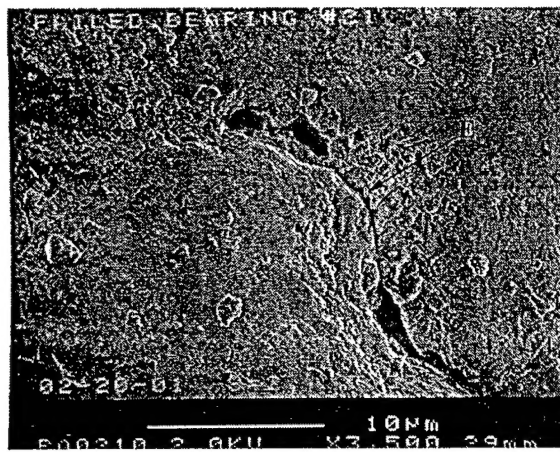
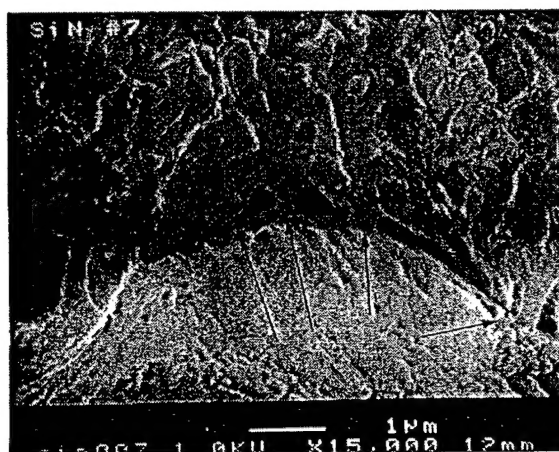
Figures 36, 37, 38, 39, and 40 are progressively higher magnification views (at 95x, 300x, 1500x, 3500x and 15,000x, respectively) of a separate crack-like feature, labeled "E," from an orthogonal perspective. Feature "E" is at the base of feature "A" near feature "D." Feature "A" is labeled in Figures 36, 37, and 38 for orientation. The feature "E" is just inboard of the tightly spaced Wallner lines in the upper right hand corner of Figure 37, which reinforces the notion that feature "E" is in the right location to be the site for fracture initiation.

Figures 39 and 40 show an interesting feature in the crack-like feature "E." Ligaments span the crack-like feature. The ligaments have a distinctive elliptical shape that might be characteristic of the neck that forms during sintering and pore consolidation. The neck's elliptical shape might be interpreted as the negative radius of curvature that forms at the junction between two sintered particles. That is, the ligaments may be the remnants of a string of small sintering voids that did not fully densify. If so, then the ligaments might be expected to be glassy pockets rich in the liquid-phase sintering aids used in this ceramic. It is uncertain, however, whether the ligaments represented the initiation site for the fracture, whether the ligaments developed as damage late in the fracture, or whether the ligaments were unrelated to the fracture.

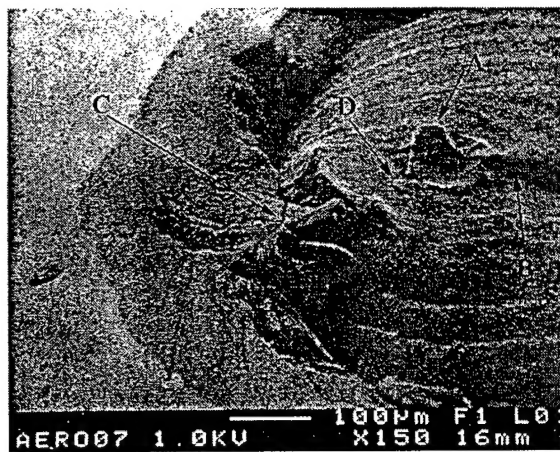
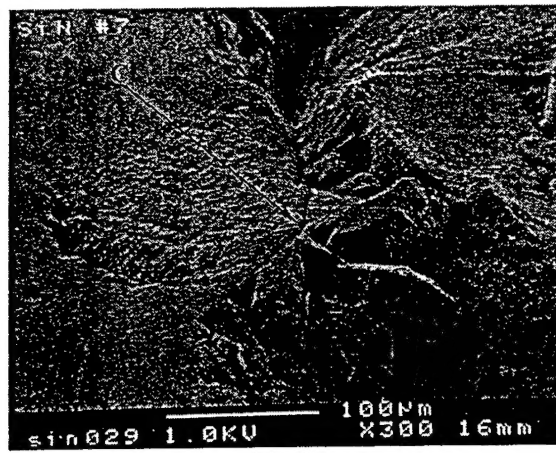
An interesting "star burst" pattern, labeled "C," is visible in Figures 32, 36, 41, and 42. The high-magnification view in Figure 42 shows several cracks radiating from a central "pit." It is uncertain whether the star burst represents the fracture initiation or whether it occurred early or late in the fracture.
